TECHNICAL NOTE 3215

TESTS OF BONDED AND RIVETED SHEET-STRINGER PANELS

By Leonard Mordfin and I. E. Wilks

National Bureau of Standards

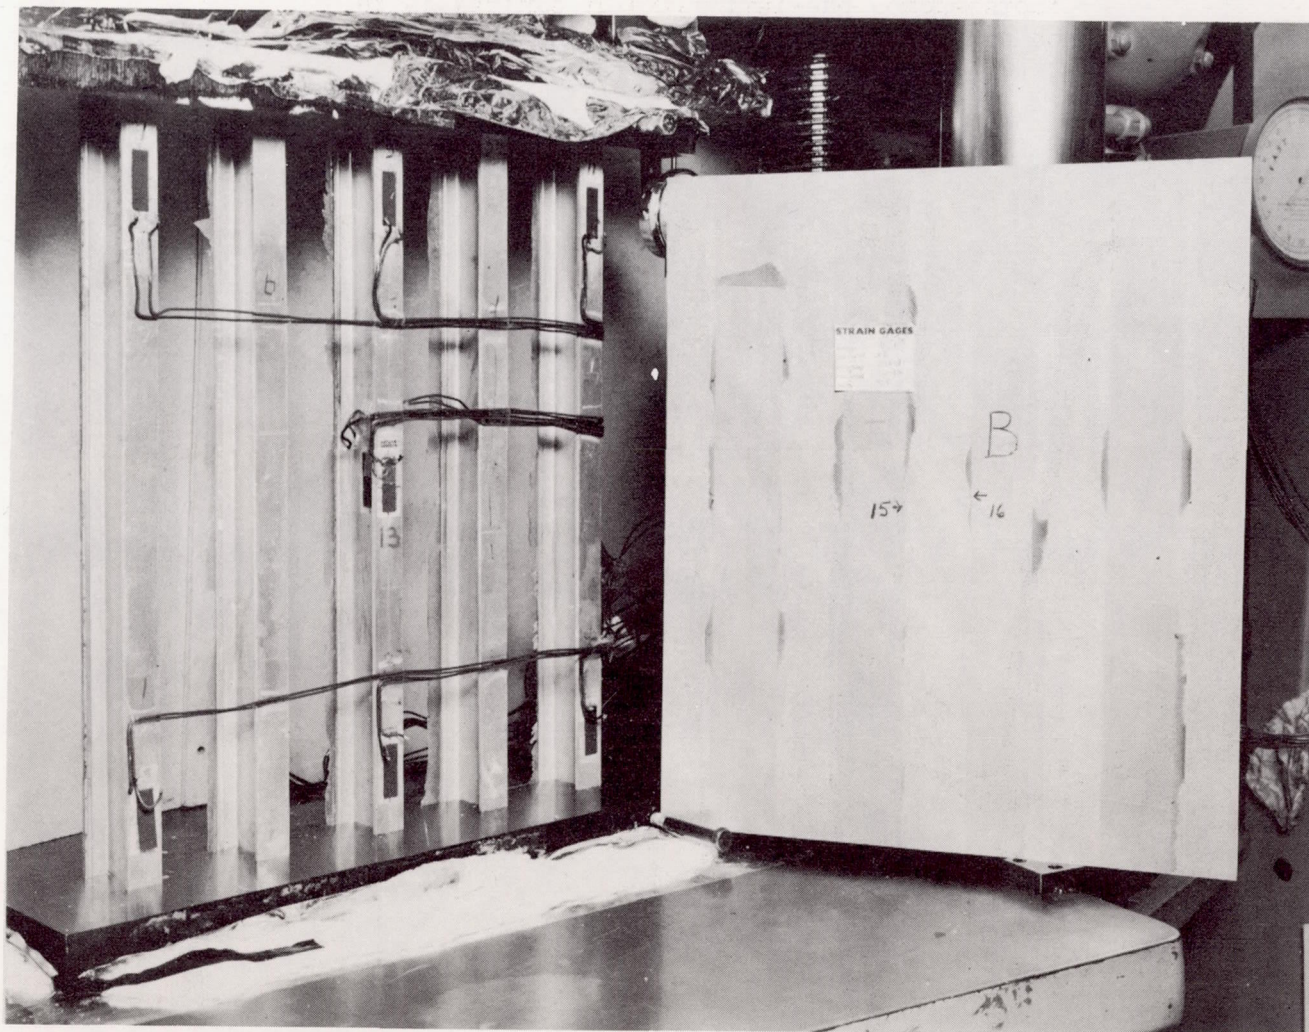
Failure in the Araldite bonded panels Af-1, Af-2, and Af-3 occurred in the bond. In panels Af-1 and Af-2 this failure took place at a load of about 100,000 pounds with the sheet explosively ripping free of the stringers and blowing out of the testing machine. The stringers remained in the testing machine in perfect testing position (fig. 11) and were then tested to failure. This failure was due to column action. The stringers buckled in a plane parallel to the original plane of the sheet and some of the reinforcing strips ripped off (fig. 12).

L-83296  
Figure 11.- Araldite bonded panel Af-2 after sheet ripped free of stringers  
at 101,800-pound load in axial flat-end compression.

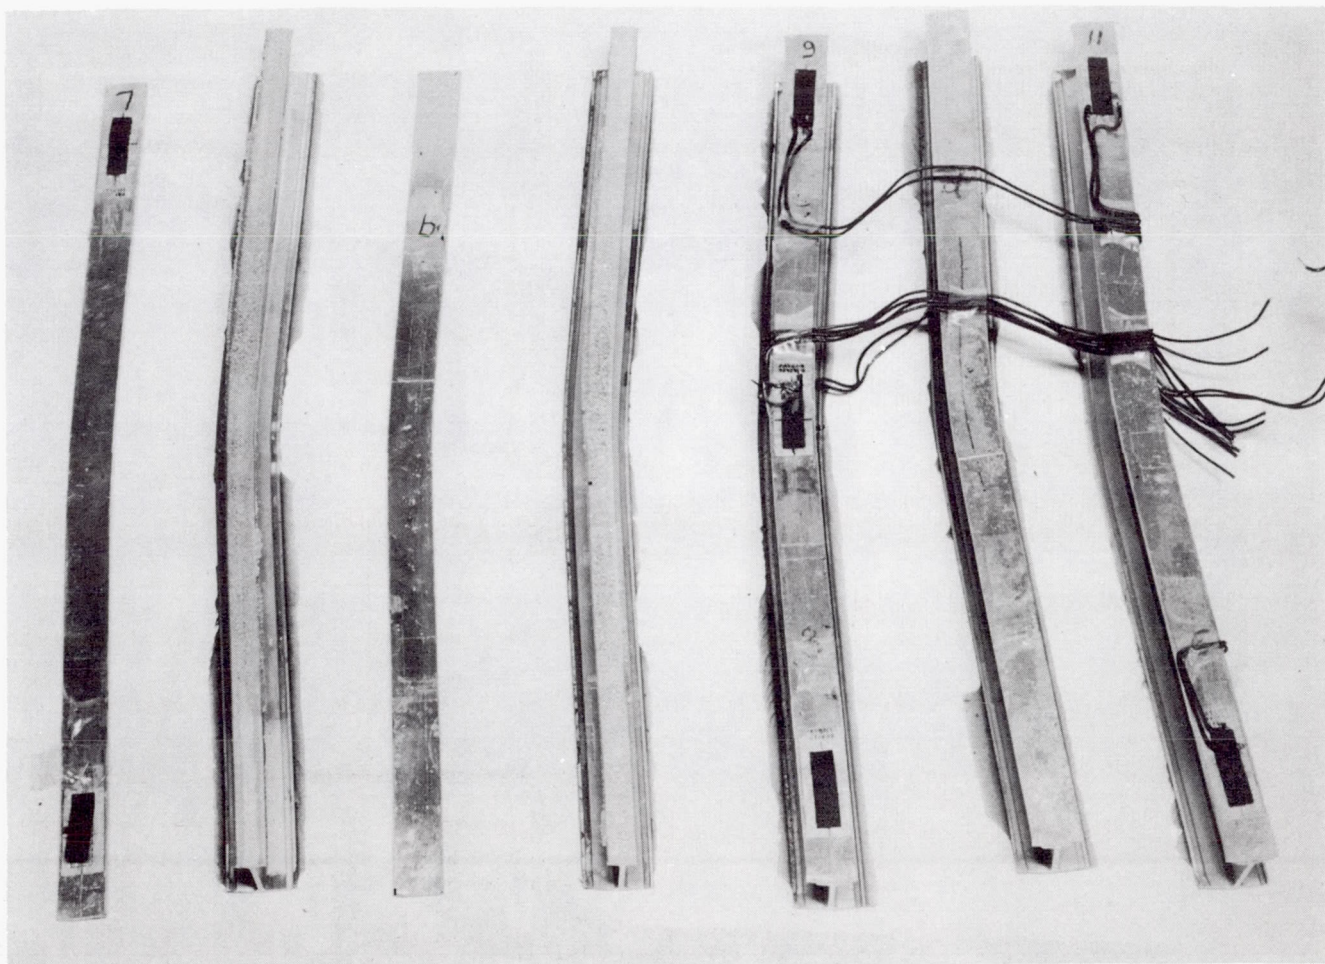
Figure 12.- Stringers and reinforcing strips of Araldite bonded panel Af-2  
after failure in axial flat-end compression.

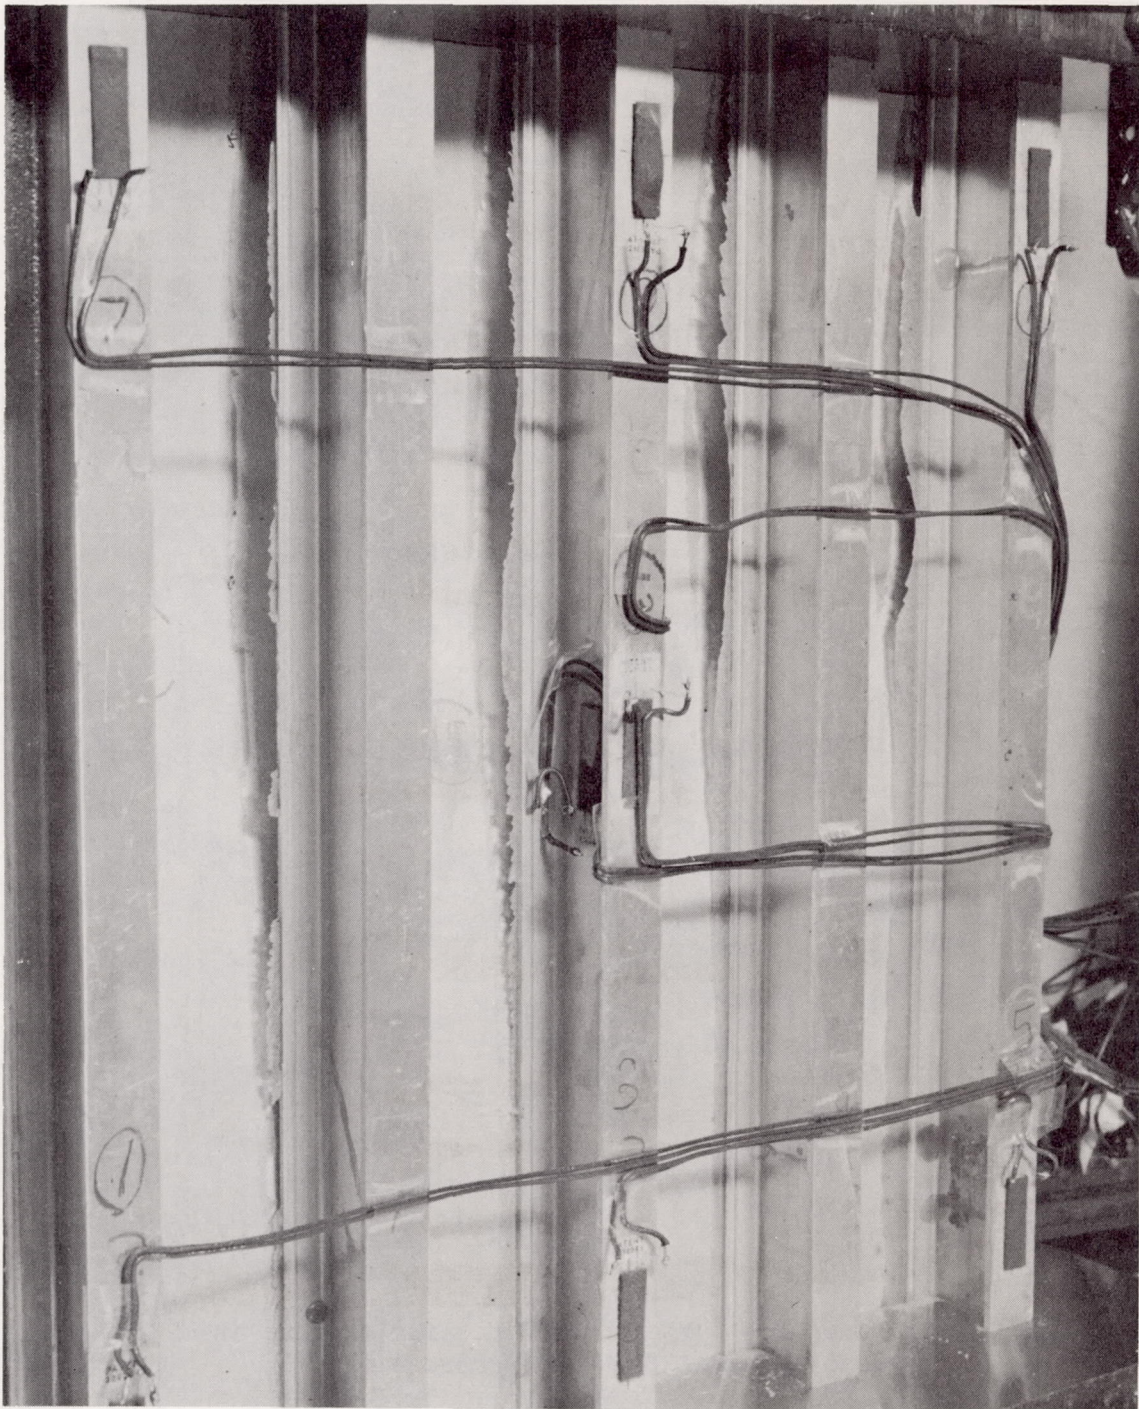
The bond of panel Af-3 failed at a considerably lower load (78,000 pounds) than those of panels Af-1 and Af-2. At this point two-thirds of the sheet ripped free (fig. 13). Further testing produced a maximum load of 105,200 pounds at which point the entire sheet ripped free and the stringers buckled. Examination of the bonded surfaces after failure indicated that the premature bond failure in panel Af-3 was due to inferior fabrication. The adhesive on the bonded surfaces of panels Af-1 and Af-2 was more or less uniform and porous, while on panel Af-3 some areas had no adhesive while others showed excess adhesive and no porosity. The inferior fabrication of panel Af-3 was not evident before testing.

Figure 13.- Araldite bonded panel Af-3 after initial failure in bond at 78,000-pound load in axial flat-end compression.

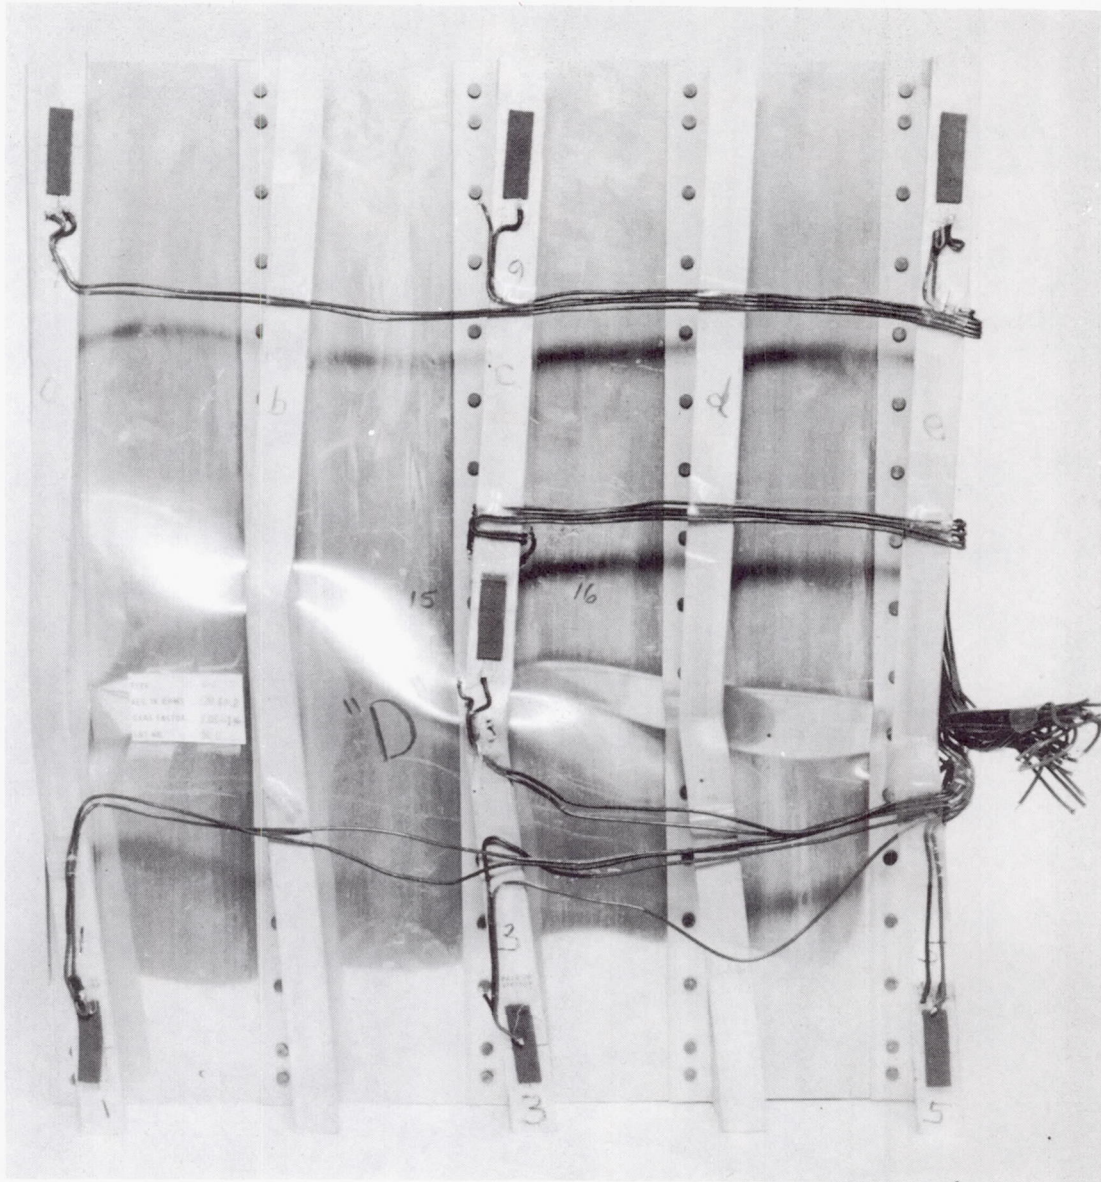
Riveted panels Rf-4, Rf-5, and Rf-6 all failed because of local buckling of sheet and stringers between rivets near the midlength of the panels (fig. 14). Failure occurred at maximum load in all three cases. The loads and average stresses at failure are given in table 3.

Figure 14.- Riveted panel Rf-4 after local buckling failure at 82,700-pound load in axial flat-end compression.

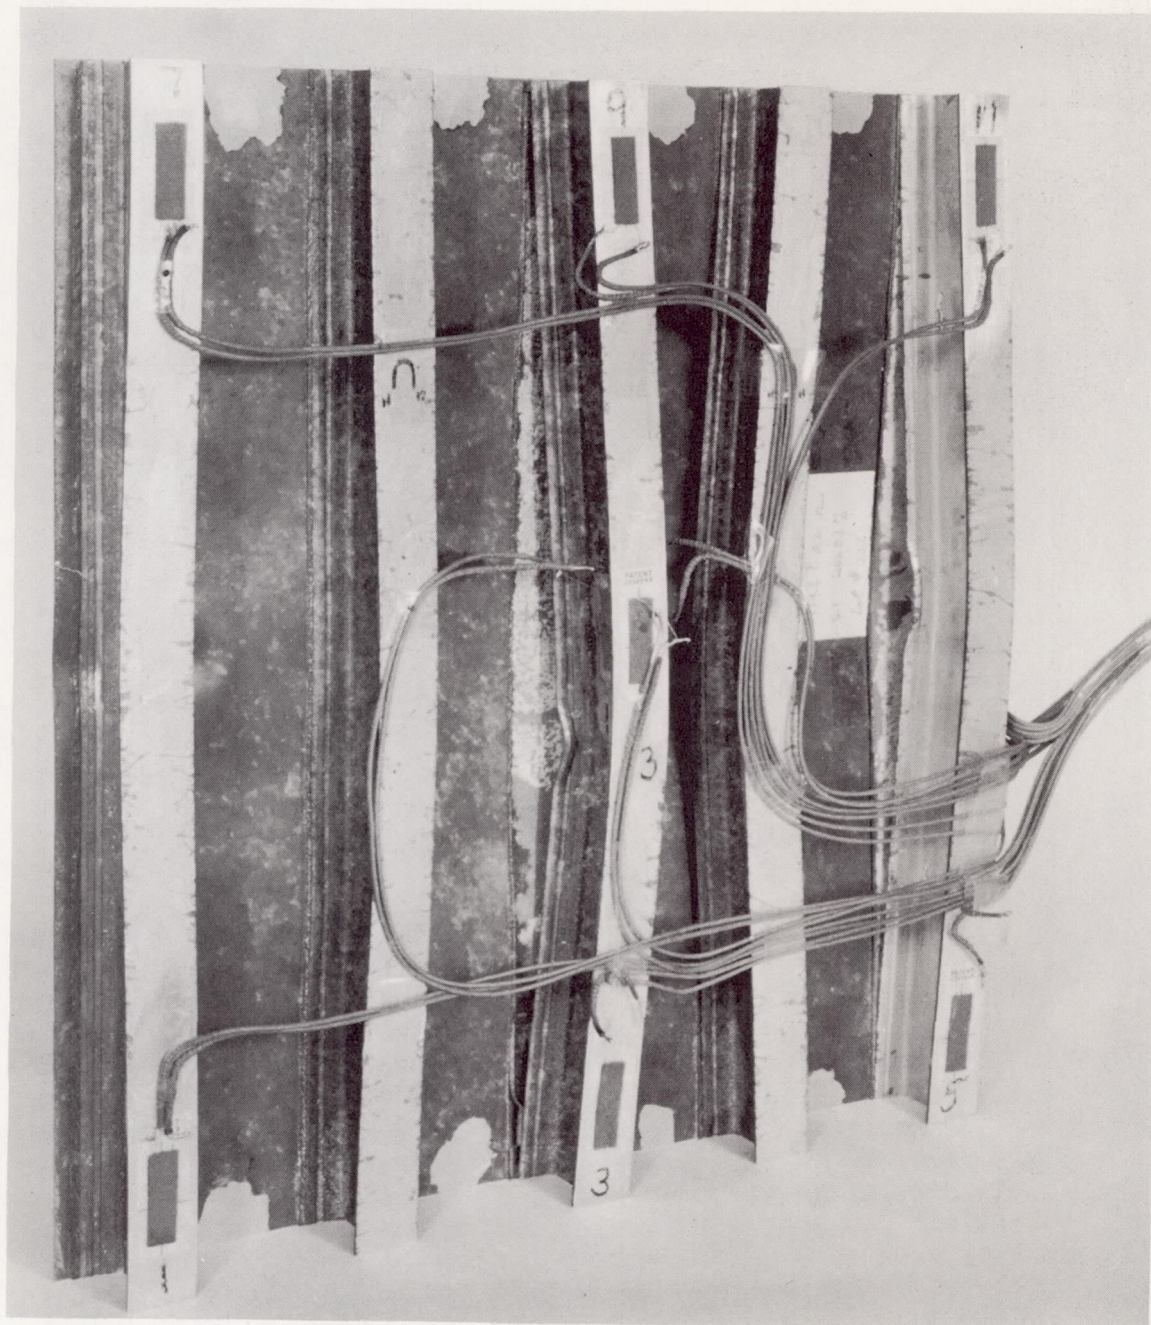
Failure of the Metlbond bonded panels Mf-19, Mf-20, and Mf-21 was due to column buckling of the stringers in a plane parallel to the plane of the sheet (fig. 15) and the consequent destruction of most, but not all, of the bond. Failure occurred at maximum load. The maximum loads and average ultimate stresses are given in table 3.

Figure 15.- Metlbond bonded panel Mf-21 after failure at 142,000-pound  
load in axial flat-end compression.

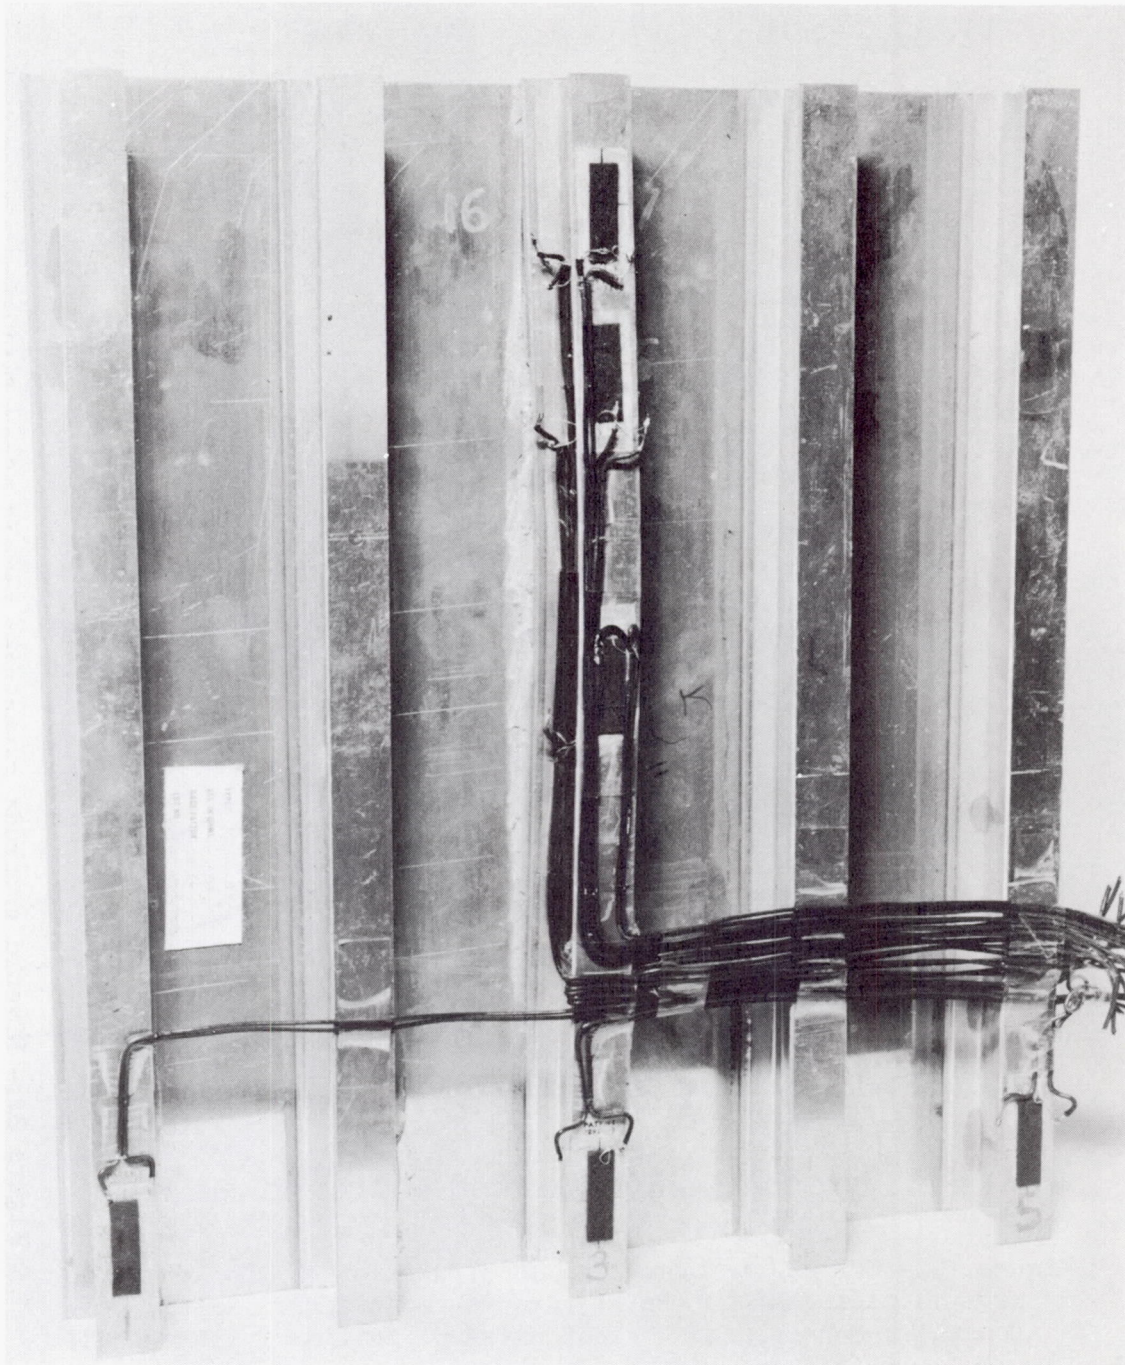
Figure 20.- Araldite bonded panel Ap-7 after column failure of center stringer at 23,500-pound load.

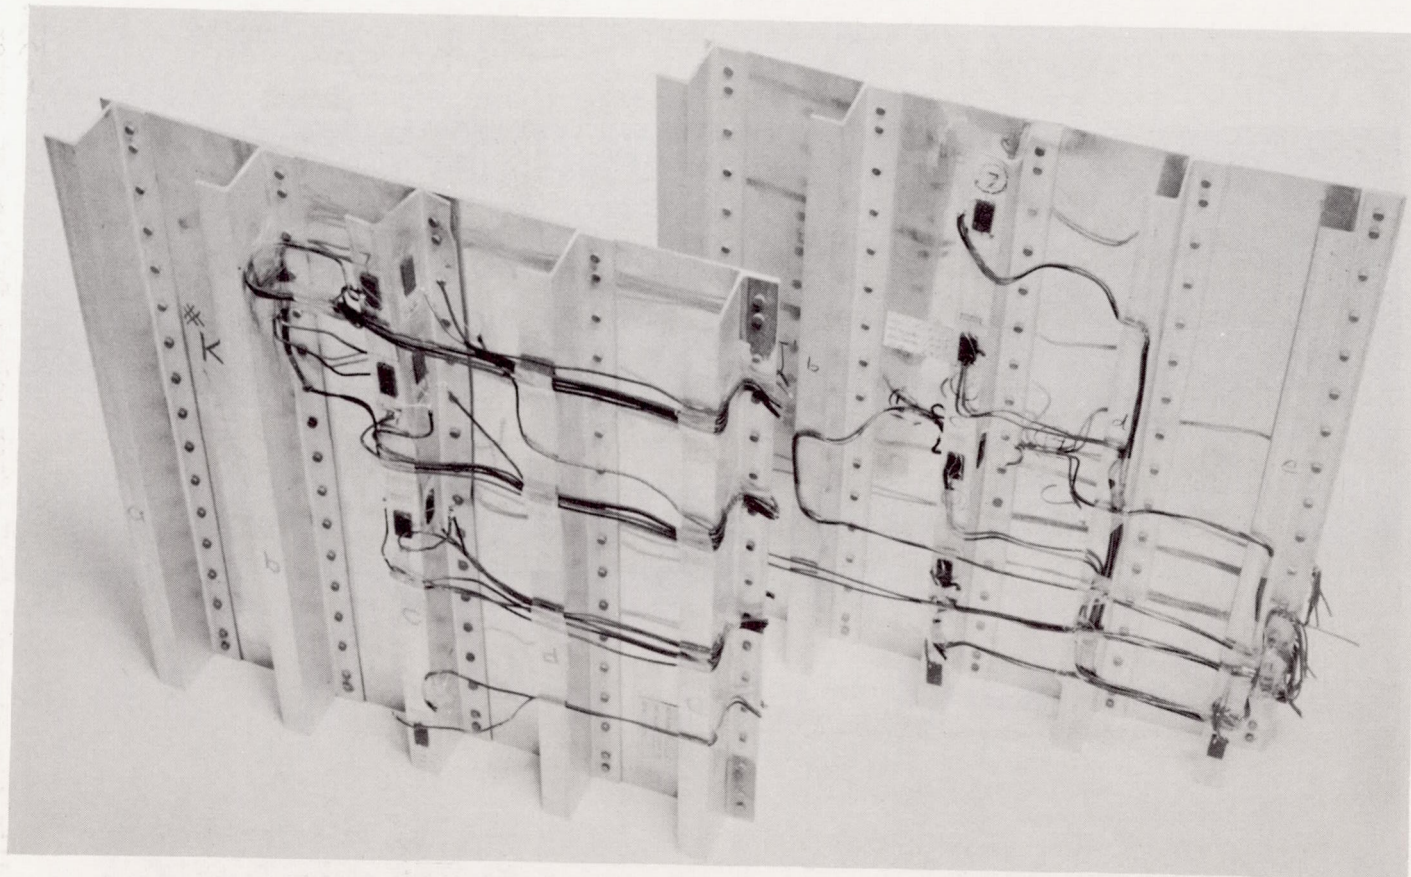
Figure 21.- Riveted protruding-stringer panels after failure.

Bonded panel Ap-8 and riveted panel Rp-12 were tested first. They had protrusions of nominally  $1/2$  inch. At 19,000 pounds the top half of the bond holding the center stringer to the sheet of panel Ap-8 ripped. Further testing produced a maximum load of 25,200 pounds where the bond failed almost completely and the stringer buckled in a plane parallel to the sheet because of column action. Riveted panel Rp-12, however, failed at 14,100 pounds because of local crushing of the protruding portion of the center stringer. Since the latter type of failure did not offer a good comparison between the two types of joints, the protrusions of the remaining panels Ap-7, Ap-9, Rp-10, and Rp-11 were cut down to 0.1 inch in an attempt to eliminate local failures in the protrusions. Bonded panels Ap-7 and Ap-9 then failed similarly to panel Ap-8 (fig. 20). Riveted panel Rp-11 also failed satisfactorily. At 12,500 pounds the top rivet sheared. Further testing yielded a maximum load of 13,400 pounds where the top half of the center stringer buckled torsionally (fig. 21(a)). Inspection showed the top nine rivets to be sheared. Riveted panel Rp-10, unfortunately, failed like panel Rp-12 because of local crushing in the protrusion (fig. 21(b)).

(a) Riveted panel Rp-11 after torsional buckling failure of center stringer at 13,400-pound load.

(b) Riveted panel Rp-10 after local crushing failure in protrusion of center stringer at 15,700-pound load.

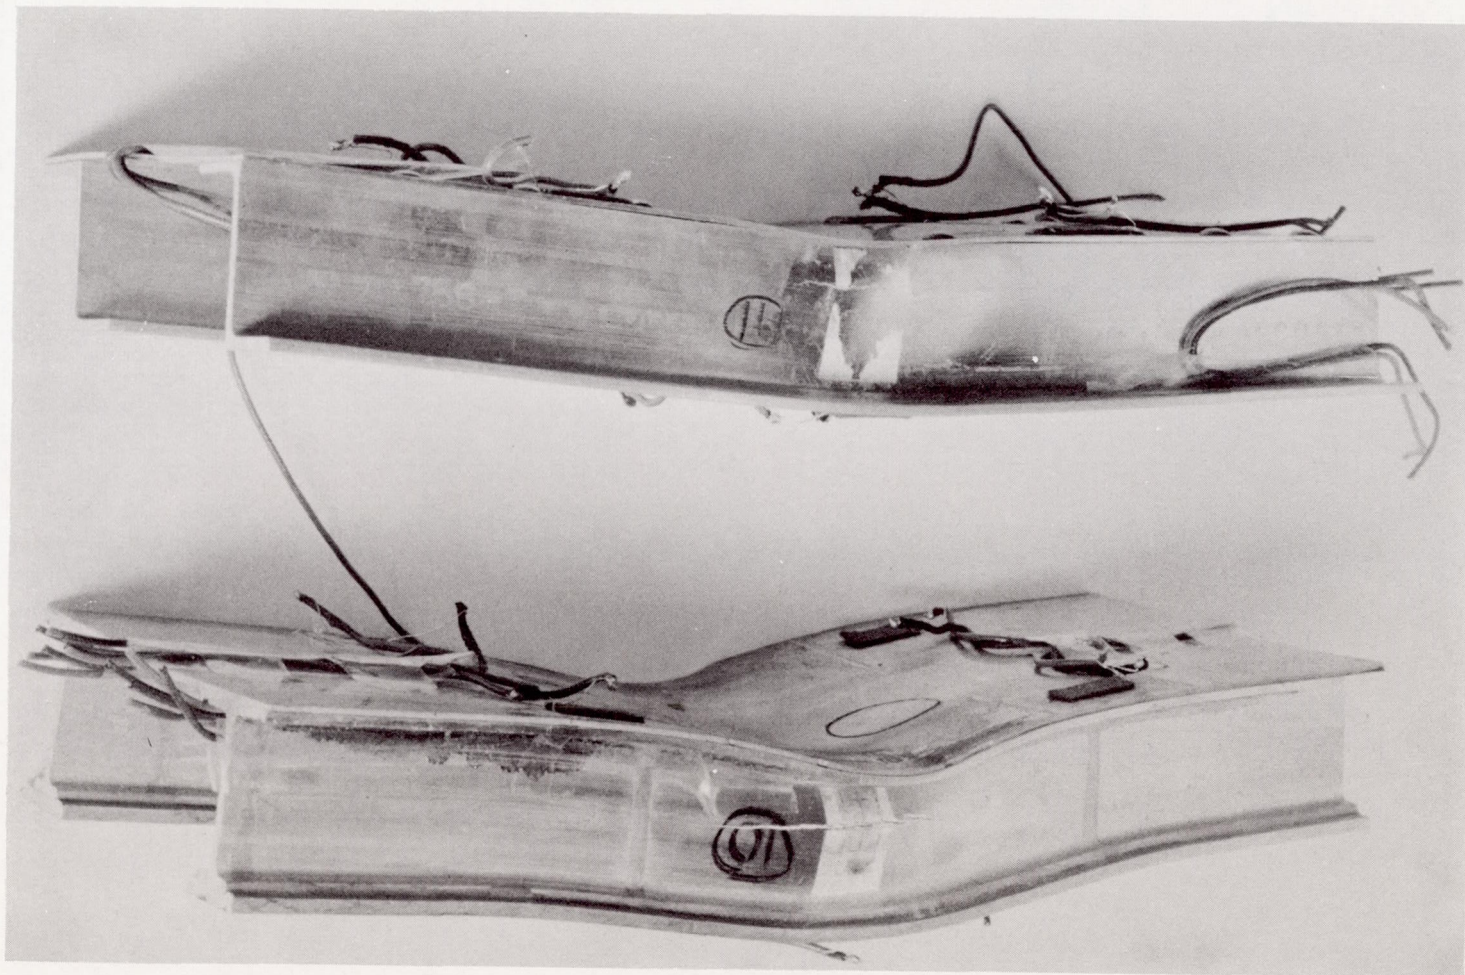
Failure of all panels was due to buckling of both stringer webs directly under the applied load, despite the fact that the outstanding stringer flanges had been stressed far beyond the elastic limit. With panels Ab-13, Ab-15, Rb-16, and Rb-18, this buckling increased at essentially constant load until fracture of the webs occurred. Representative failures are shown in figure 27. With panels Ab-14 and Rb-17 no fractures were obtained because the test setup collapsed from excessive movement of the supports caused by the sudden buckling of the webs and the accompanying deflection and shortening of the panels. Hence, while no fracture was obtained in these two tests, the maximum loads recorded are undoubtedly very close to the actual maximum loads and may be safely considered as such. In the test of panel Rb-16, two rivets failed in shear during the few seconds that elapsed between the start of buckling and the fracture of the webs.

Figure 27.- Riveted panel Rb-18 (top) and Araldite bonded panel Ab-15 after failure at 14,300- and 26,200-pound loads, respectively, in bending tests.
